What happens when low quality, unproven materials are used in solar panels?

Revealing the results of over 4 million solar panels inspected in 275 Installations across the world

Dupont Field Module Inspection Study: Result Summary

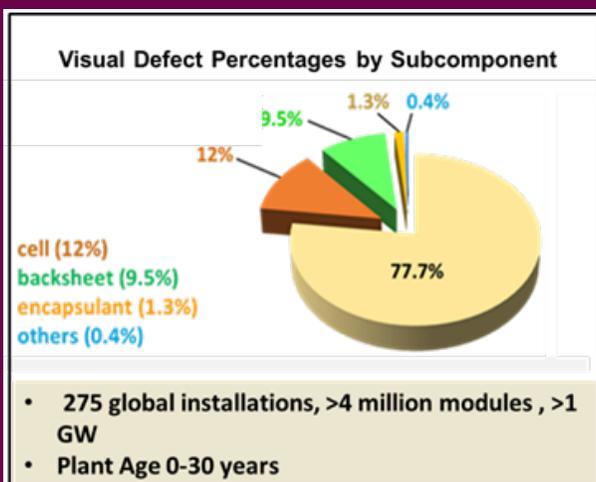
The focus of this study was to inspect solar panels to understand the real aging and degradation of modules in the field. The study included visiting more than 275 installations (>1GW) and inspecting more than 4 million modules installed around the globe. Figure 1 shows the summary of visual defects observed in different materials. About 22% of the inspected modules exhibited visual defects in one or more components. Defect rate was found to be highest in cells and observed in about 12% of modules checked. This was followed by backsheet defects which were observed in 9.5% of modules we evaluated. Encapsulation defects were observed in 1.3% of the modules. Some visual defects were observed in junction box and glass as well. Typical failure modes observed were cell snail trails and ribbon corrosion backsheet cracking, delamination, abrasion and yellowing; and encapsulant yellowing and delamination from glass. High defect rates were observed in solar cells, leading to accelerated power loss and solar backsheets leading to current leakage, inverter tripping, loss of insulation and increased safety risks.

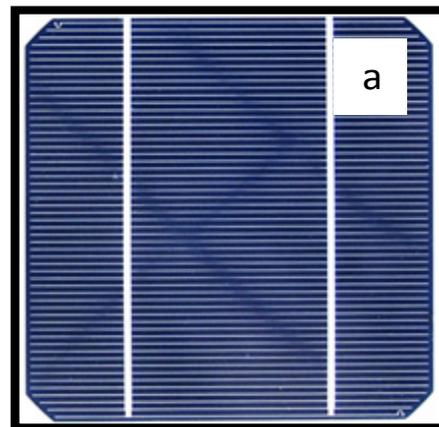
The visual changes in cells mainly included snail trails. Snail trails, as shown in figure 2a, is a discoloration of fine silver grid lines on the front side of the cells, which develop mostly along the cell micro-cracks. This phenomenon occurs due to a reaction between EVA encapsulant and silver grid lines in the presence of oxygen and UV light. [ref 1] Snail trail defects confirm the presence of cracks in the cells that can impact the power generation of the module over time. Solder Ribbon Corrosion- can be seen as a color change on the flat wires used to interconnect individual cells – in many modules as shown in figure 2b. This defect can lead to increased resistivity and, in extreme cases, can lead to ribbon break and module power loss.

Figure 2: a) Snail trails along cell crack; b) Ribbon

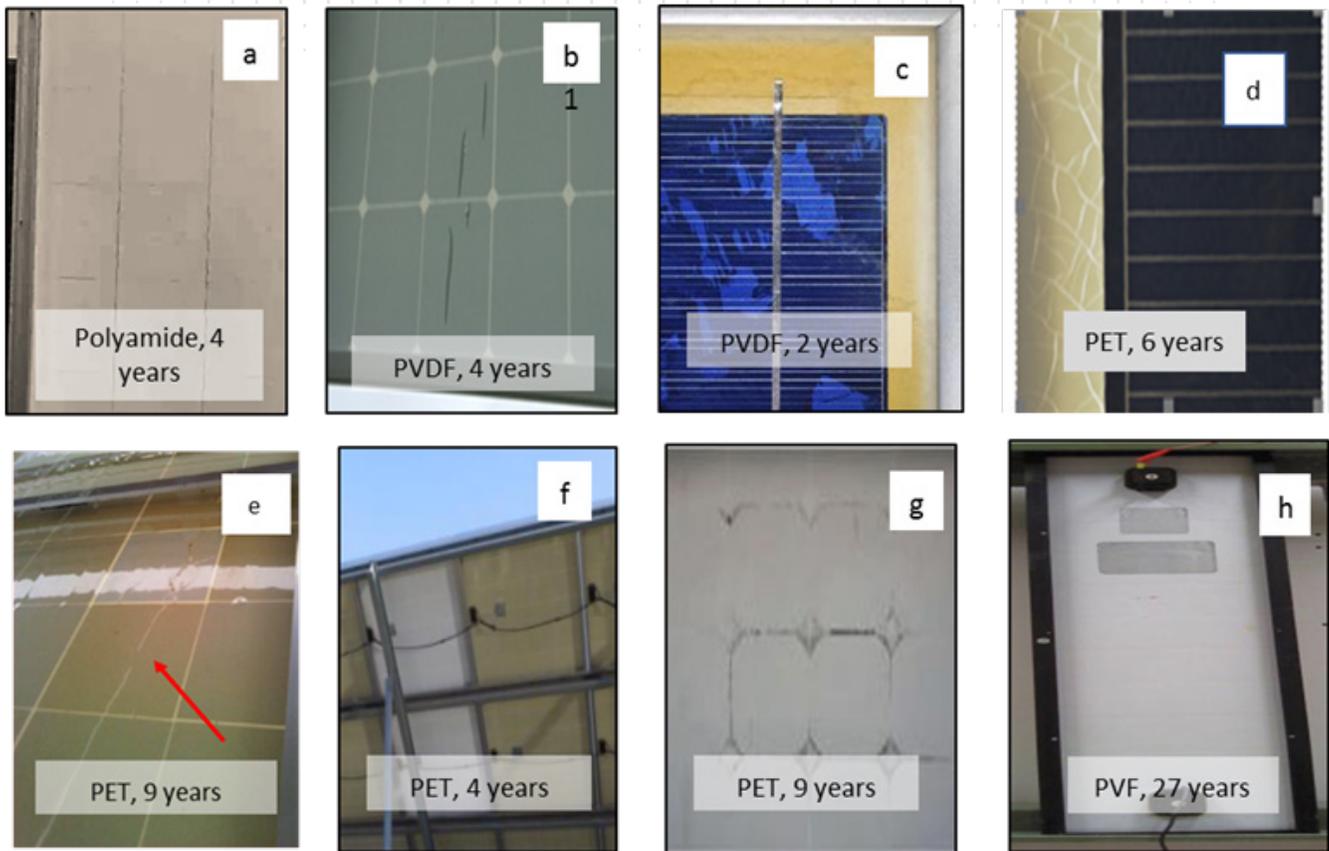
■ In backsheets, observed defects included cracking and yellowing of the inner layer, and cracking, yellowing, delamination and erosion of outer layer as shown in figure 4. While cracking, delamination and abrasion of the backsheets represents actual failures of the backsheets, change in appearance of the backsheet such as yellowing is an indicator of polymer degradation and can potentially result in the embrittlement and cracking of the backsheet. Cracking is typically associated with the loss of mechanical properties and increase in brittleness of the backsheet material / materials due to exposure to UV radiation, heat and humidity. The brittle material eventually cracks due to thermal stress caused by day-night changes in the temperature. Erosion of the outer layer is caused by degradation of the polymer outer layer. Loss of the outer layer can also happen due to abrasion by airborne particles propelled by wind, in the extreme case sandstorms at high speeds. Erosion of the outer layer can lead to a significant reduction in its thickness over time. These backsheet failures can expose energized electrical components and accelerate power degradation, create electrical safety hazards, or both. Inner layer backsheets cracking has recently been linked to moisture ingress and subsequent overloads and inverter tripping.

Many backsheet types are observed in the field [Ref. 4,5], such as backsheets based on Polyamide film, PVDF Film, PET Film, Fluoropolymer coatings, and Tedlar® PVF film as outer layers. Typical observations are shown in figure 4. Note the Tedlar® PVF based backsheet (figure 4h) shows no visible defects and the field had <0.5% annual power loss at 27 years of service

- Polyamide based-backsheets: extensive outer layer cracking (figure 4a)
- PVDF-based backsheets: Outer layer cracking (figure 4b); Inner layer yellowing (figure 4c)
- PET backsheets: Inner layer cracking (figure 4d), outer layer cracking (figure 4e), yellowing (figure 4e and 4f) and abrasion (figure 4g)

In many cases, the cracking of backsheet inner / outer layer was leading to current leakage, which is a serious safety hazard. Moreover, in some cases, the defect led to significant power loss in the form of module ground faults (no power output) and inverter tripping (no power output from the whole block).

Figure 4: a), b) AAA and PVDF outer layer cracking; c) PVDF inner layer yellowing; d) PET Inner layer cracking; e) PET outer layer cracking and f) yellowing; g) PET outer layer abrasion; h) PVF backsheet no backsheet degradation and <0.5% annual power loss after 27 years in field
