Materials can be key to differences in module durability

Defect assessment | DuPont Photovoltaic Solutions recently completed a five-year study of commercial crystalline silicon PV systems, amassing a wealth of new information about PV system field experience and PV module defects. Principal investigator Alexander Bradley discusses the findings, which, in addition to supporting the company's ongoing analysis of materials performance, are expected to provide benefits across the industry. Building on the industry knowledge pool contributes towards the standardisation of performance expectations across the solar industry, enables the development of more stringent risk mitigation techniques, and helps purchasers of solar power systems make educated and informed materials assessments

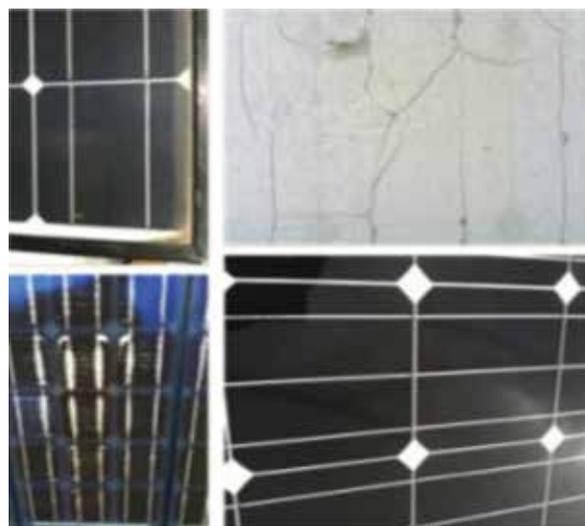
The cell may be the most valuable part of a module, but the discoloration of encapsulants and backsheets can also exact a heavy price (see Fig. 3). Discoloration can cause embrittlement of these two electrical insulating components; this in turn can lead to delamination and the loss of mechanical properties, which can compromise electrical insulation. These issues are also grounds for potential workmanship warranty claims.

Figure 3. Representative visual defects (clockwise from top left): etched glass, cracked backsheet, snail trails and encapsulant discoloration.

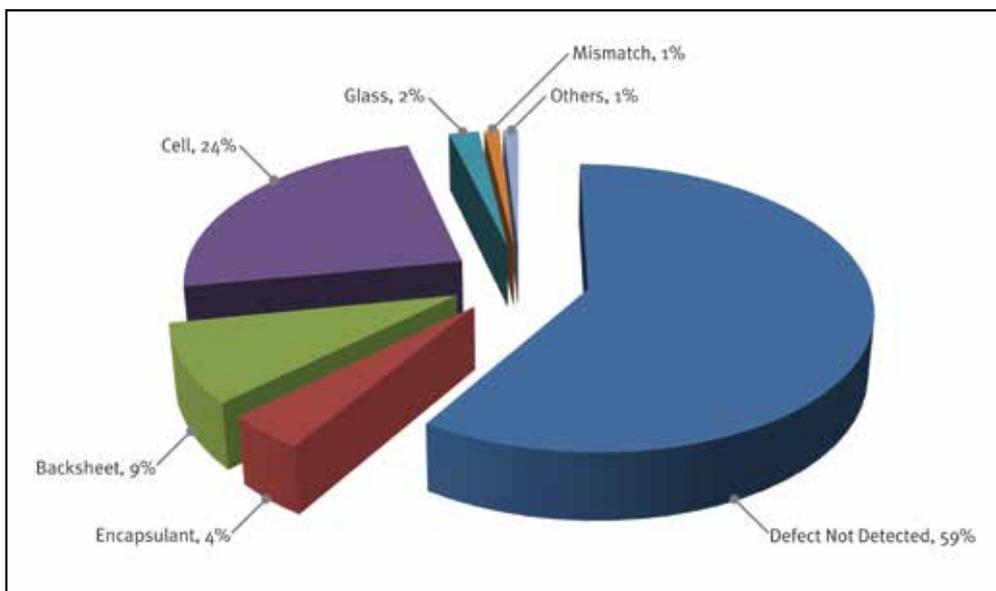
As part of the data analysis, degradation modes were combined into a small number of distinct categories. Out of all the modules surveyed, 59% had no defects; Fig. 2 shows the breakdown for the 41% with defects. In many instances, the defects were not uniform across all modules in a particular installation.

The superstrate accounted for only 2% of defects (Fig. 2). Twenty-four per cent of defects related to the cell, including hot spots (identified via thermal camera), visible corrosion, burn marks at interconnections, and cracks (identified by snail trails.) Encapsulants accounted for 4% of defects. While this percentage is low, it represents an important cause of defects, because of the resultant loss in transmission, as well as a shift in the transmission spectrum, which allows a shorter wavelength of light to penetrate the module.

Figure 2. Subcomponent visual defect percentages.

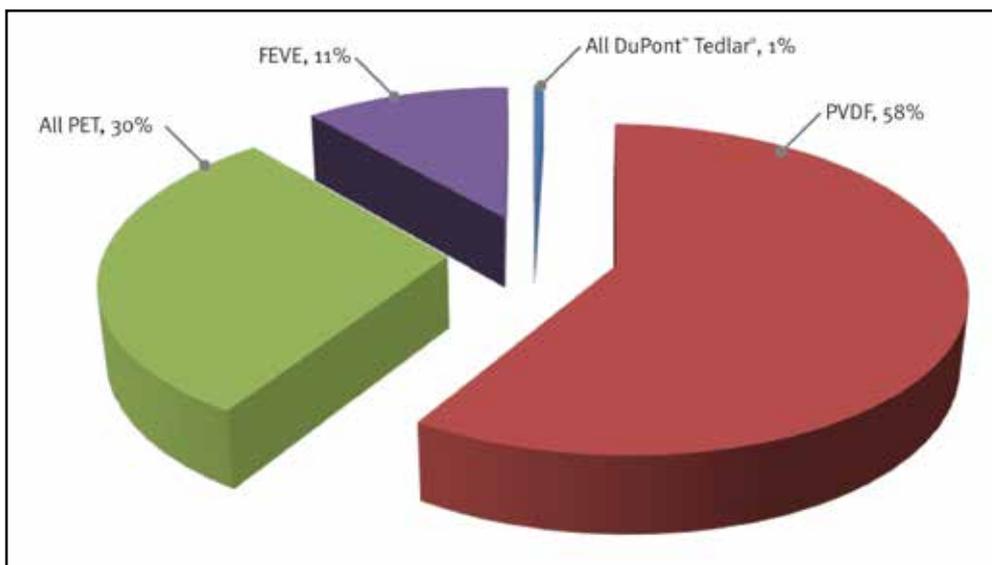
Figure 4. Backsheet visual defect percentages for different backsheet materials.

Backsheet defects accounted for 9% of the total defects, and researchers found a significant variation in the percentage of defects across different backsheet materials (Fig. 4).
